SHAFT TO BORE MISALIGNMENT

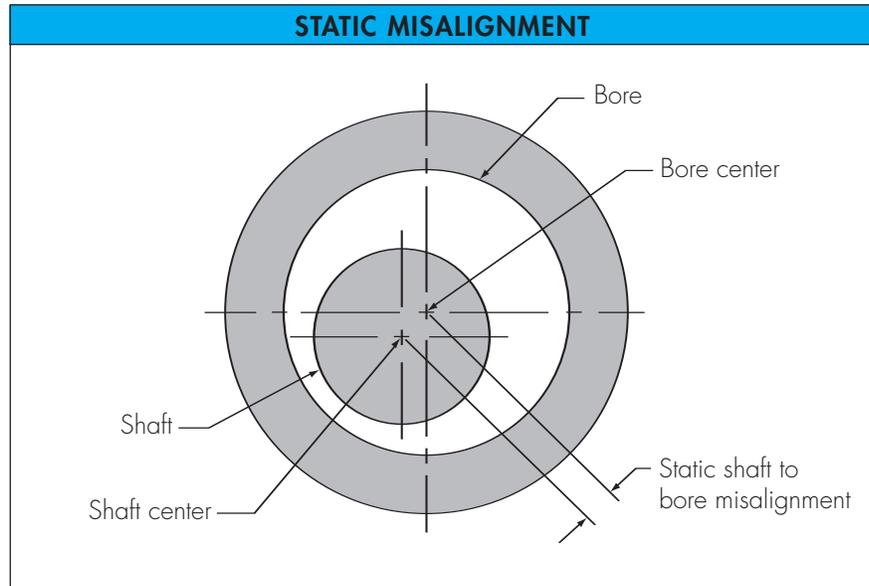
Misalignment between the shaft and bore is a static condition caused by their center-lines being offset. Evidence of this condition is seen by a wear pattern on the lip that is wider on one side of the seal. Shaft-to-bore misalignment should not exceed .003 inches (0.08 mm) for maximum seal life.

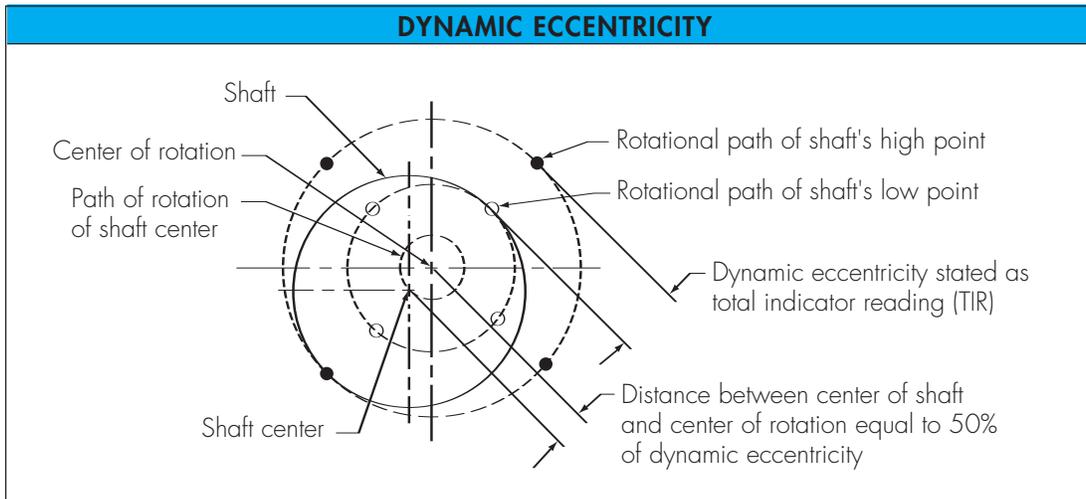
Dynamic eccentricity is the variation between the high and low point on a shaft as it rotates in the bore in which the seal is installed. As the high point on the seal rotates through 360 degrees, it causes the seal lip to flex outward. Conversely, as the low point on the shaft rotates, it requires the seal lip to flex inward with each rotation. The elasticity of the lip and its garter spring energize the lip to follow this eccentricity. As shaft RPM or

eccentricity increase, the demand on the lip to follow the shaft increases, resulting in shortened seal life. High RPM and eccentricity can cause the seal lip to raise off the shaft, being unable to follow its low point, inducing leakage. Maximum recommended dynamic eccentricity is .005 inches total indicator reading (TIR) or 0.13 mm.

Total eccentricity is the sum of the dynamic eccentricity and shaft-to-bore misalignment. This value should not exceed .008 inches (0.2 mm) to ensure maximum seal life.
